## **Analysis of the structural framework for schools affected by the Sunda Strait Tsunami in Pandeglang Regency**

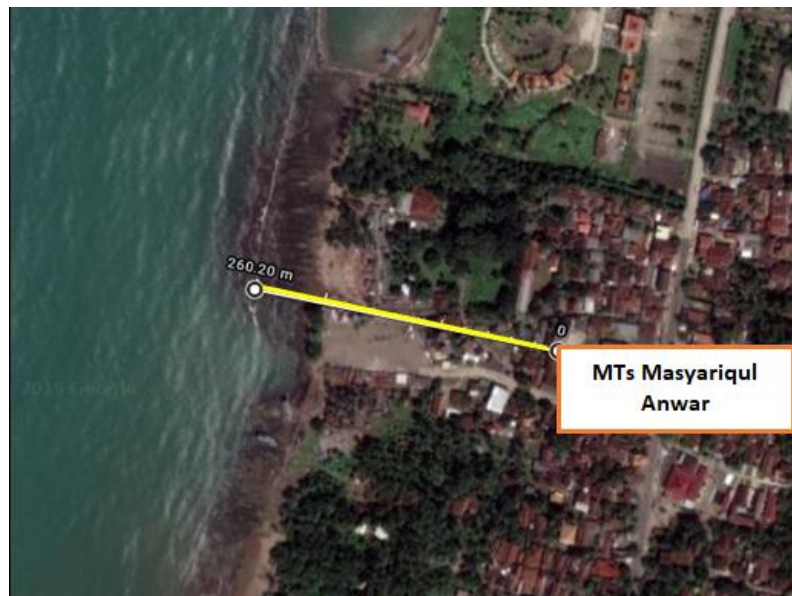
**Figure 3.** Location Distance of MTs Masyariqul Anwar from the Coastline  
Source: Google Maps, 2019

The location of the MTs Masyariqul Anwar land is back to the beach with a distance of about 260 meters from the coastline. Based on the Pandeglang Regency Tsunami Risk Map (2014), the location where MTs Masyariqul Anwar is located is in the red zone with a high level of tsunami risk.

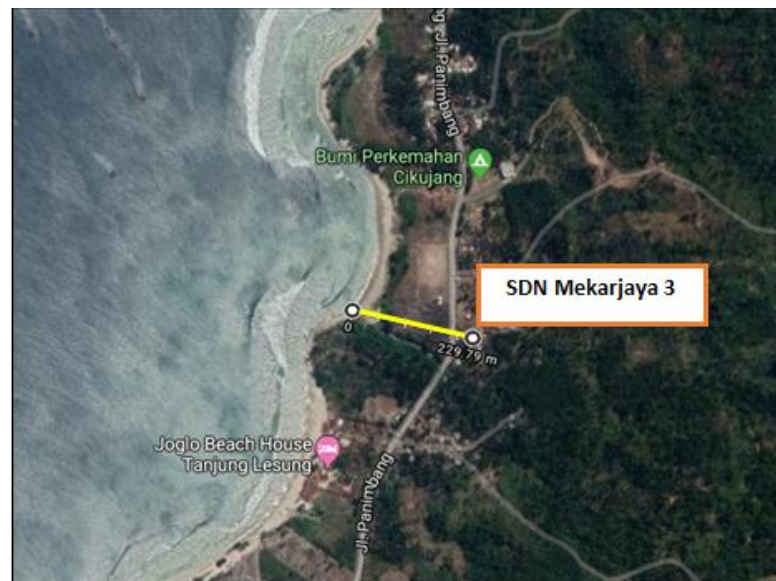
**Figure 4.** Location Distance of SDN Mekarjaya 3 from the Coastline  
Source: Google Maps, 2019

The location of SDN Mekarjaya faces the beach and is separated by Jalan Panimbang. The distance of the school from the shoreline is 229 meters. According to the Pandeglang Regency Disaster Risk Map, SDN Mekarjaya 3 is in the red zone with a high level of tsunami disaster risk.

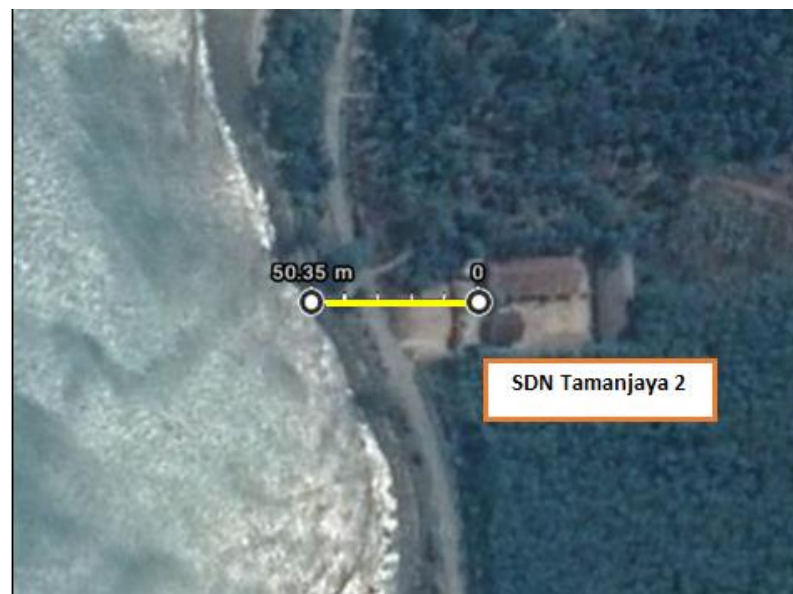
**Figure 5.** Location Distance of SDN Tamanjaya 2 from Garis the Coastline  
Source: Google Maps, 2019

Of all the schools in Pandeglang, SDN Tamanjaya 2 is the school with the closest distance from the coastline, which is only 50 meters away. The location of SDN Tamanjaya 2 is indeed in the red zone with a high level of tsunami disaster risk. This resulted in SDN Tamanjaya 2 being affected by the Sunda Strait tsunami which was severe enough to destroy one library building and damage other classrooms.

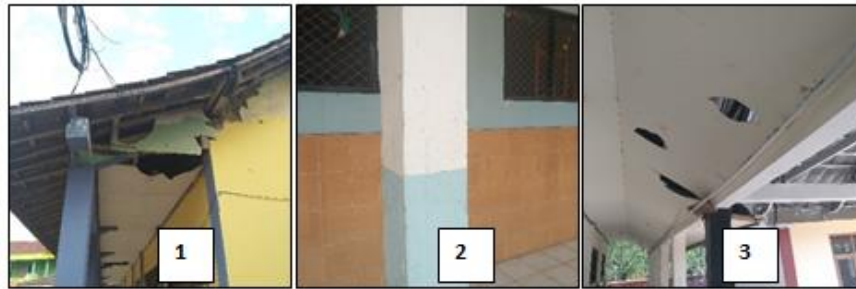
From the results of the research review at the research site, it was seen that the buildings have not undergone restoration for at least 10 years, except SDN Tamanjaya 2 which received renovation assistance from private and humanitarian organizations due to its school building being heavily damaged by tsunami waves in early 2019. What is striking in the three schools is the damage to the ceiling and roof and small cracks in the walls and columns whose material still uses heavy bricks. It can generally be seen in the following figure:

**Figure 6.** Condition of School Structure (1) Damaged Roof and Ceiling at MTs Masyariqul Anwar; (2) Cracked Column at SDN Mekarjaya 3; (3) Perforated ceiling at SDN Tamanjaya 2  
Source: Research results, 2019

Damaged and fractured conditions were found at several points in each school. So this will certainly be very dangerous for students and teachers who move in it. The basic materials of the walls and roof still use heavy materials (concrete and clay). But on the beams in each school building is still fairly safe and strong standing on the foundation.

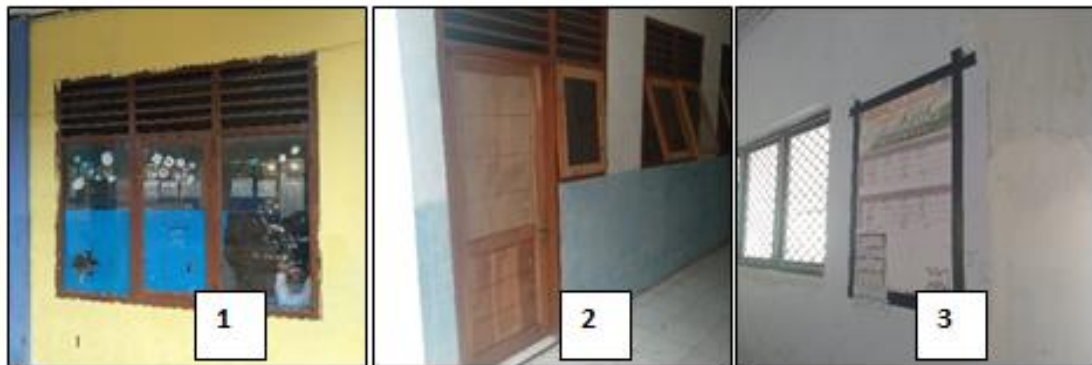
From the observations at the research site, the three schools do not yet have first aid kits in each classroom. First aid kits are only placed in the teacher's room. While the three schools also have not tied / nailed furniture that easily falls and breaks and bookshelves to the wall to strengthen the position of shelves when there is an earthquake. The three schools have also not implemented a door design that opens out. This needs to be done to facilitate the evacuation process in the event of a disaster. Figure 7 shows documentation of the results of the research site review:

**Figure 7.** Condition of School Architecture and Furniture (1) Classroom windows of MTs Masyariqul Anwar which have not used trellises; (2) The design of the door of SDN Mekarjaya 3 which still opens inward; (3) Wall decorations that are pasted using masking tape instead of frames at SDN Tamanjaya 2.
